MOISTURE PLUS
PH CAN ADD UP
TO FLOORING
FAILURE

CAUSTIC COMMENTS

BY BILL IMHOFF

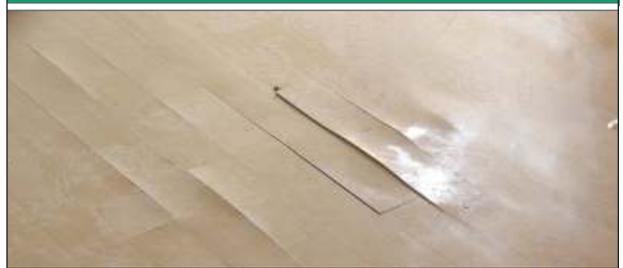
Wouldn't stay down

In Austin, Texas, a manufacturing facility struggled for 15 years with tile failures from moisture and high pH. It spent \$250,000 to remove failed floor tile and encapsulate the slab with a moisture barrier to install a warrantable floor covering that provides 2,000-psi strength for the massive machinery that moves across this floor (Figure 1).

Figure 1. Moisture and pH problems led to strip failure, stressed vinyl composition tile and efflorescence in the seams.

Any moisture or pH problem can be fixed at a price. At the Austin high-tech facility, the fix involved removing the flooring and preparing, sealing and cementing the original concrete. This encapsulated the high humidity in the floor. The facility spent hundreds of thousands of

dollars to fix the problem, but it was critical that the flooring be able to bear the weight of large, heavy equipment without buckling.

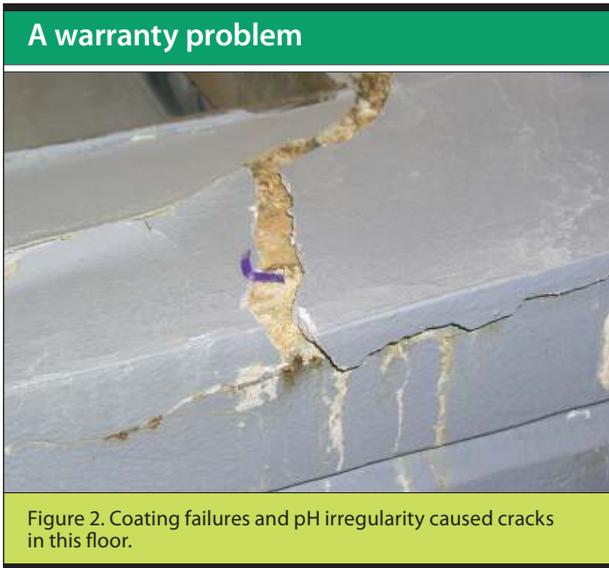
A warranty problem

Balancing slab pH and moisture level can be challenging and costly. Concrete has a naturally high pH. But, many flooring manufacturers won't warranty installations if the pH is at natural levels, even though moisture is low (Figure 2). Nationwide, moisture and pH-related flooring problems have reached the billion-dollar level annually, according to independent concrete flooring expert Scott M. Tarr, principal engineer at CTL Group, Skokie, Ill. Factors driving these problems include:

Figure 2. Coating failures and pH irregularity caused cracks in this floor.

Most pH problems are caused by active vapor transmission bringing calcium hydroxide to the surface. Over time, the moisture evaporates, leaving behind higher-pH solid materials. In extreme cases, an efflorescence bloom can occur.
